**INDEPENDENT  
ENVIRONMENTAL AUDIT  
REPORT**

Facility 21D and 21F School Drive, Tomago NSW  
2322

Remondis Australia Pty Ltd  
10 October 2023

AU122283 R1

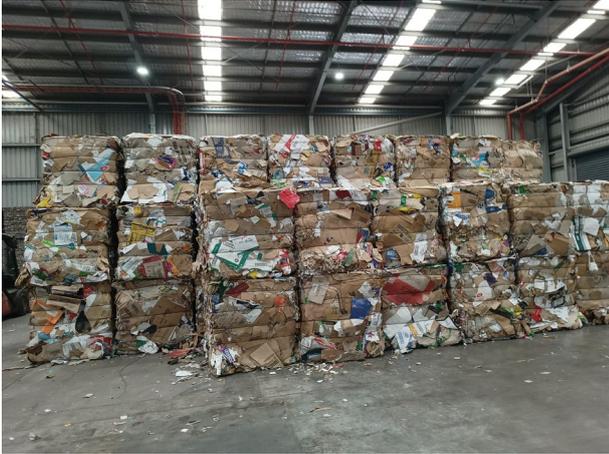
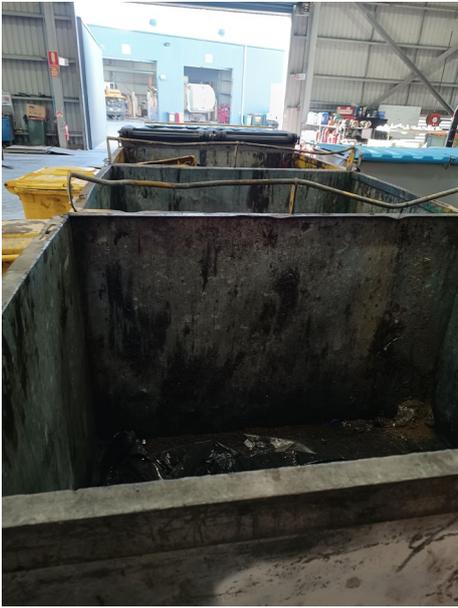
<p>Photo Number: G34, G35, G37, G113</p>	<p>Date: 10/7/2023</p>

<p>Description:</p> <p>Waste types observed onsite.</p> <p>All waste was observed to be stored within buildings</p> <p>Baled material did not exceed 4m high.</p>

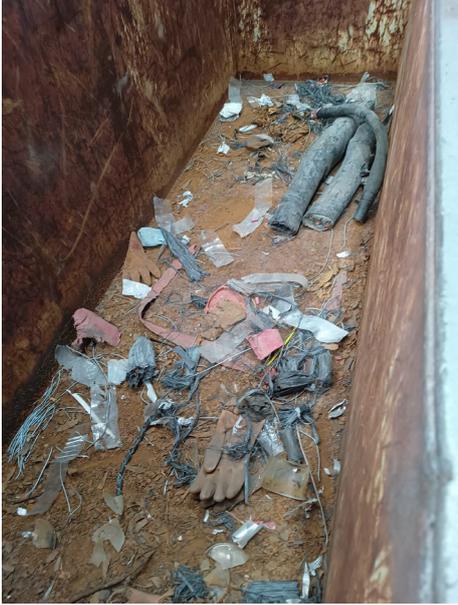
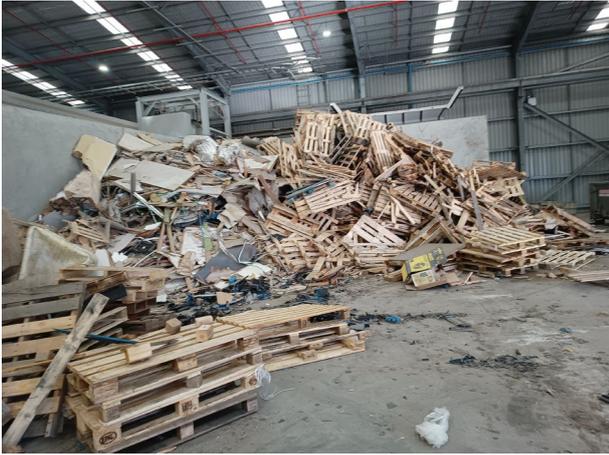
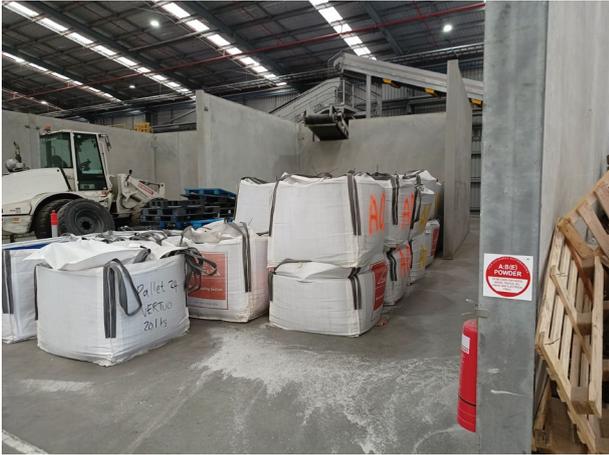
<p>Photo Number: G34, G35, G37, G113 (cont.)</p>	<p>Date: 10/7/2023</p>

<p>Description:</p> <p>Waste types observed onsite.</p> <p>All waste was observed to be stored within buildings.</p>

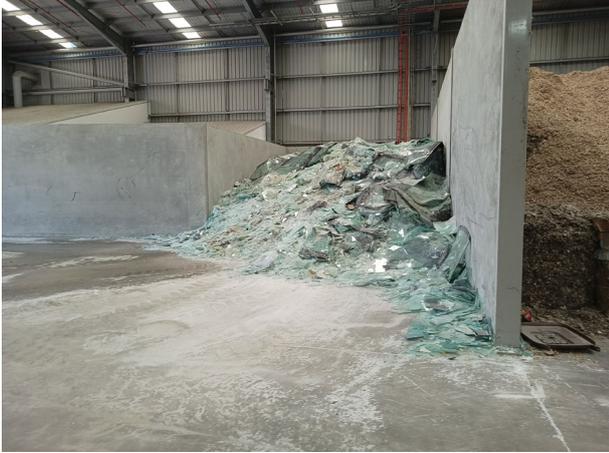
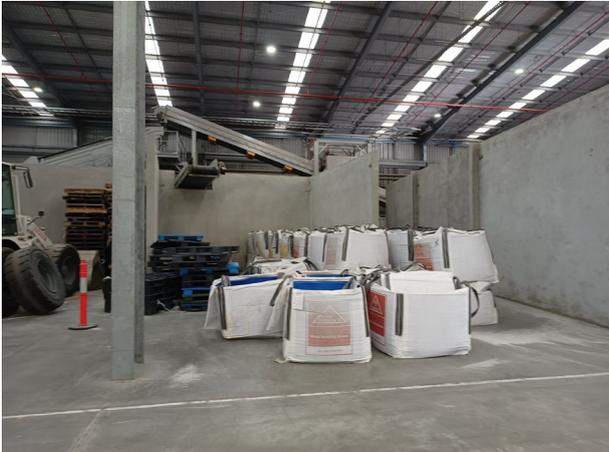
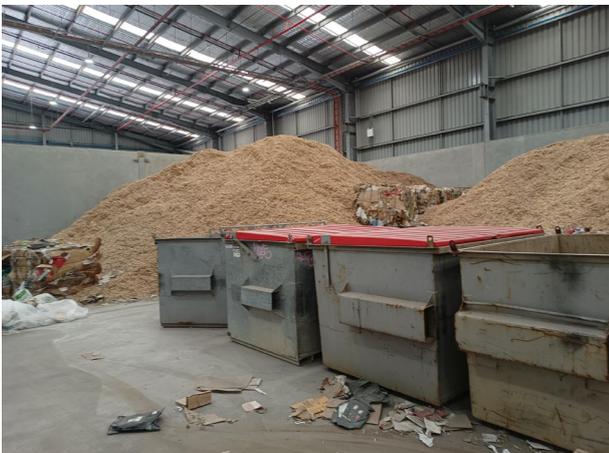
<p>Photo Number: G34, G35, G37, G113 (cont.)</p>	<p>Date: 10/7/2023</p>

<p><b>Description:</b></p> <p>Waste types observed onsite.</p> <p>All waste was observed to be stored within buildings.</p>

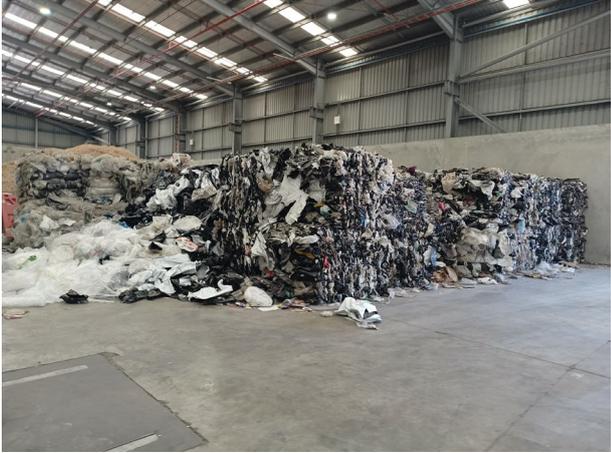
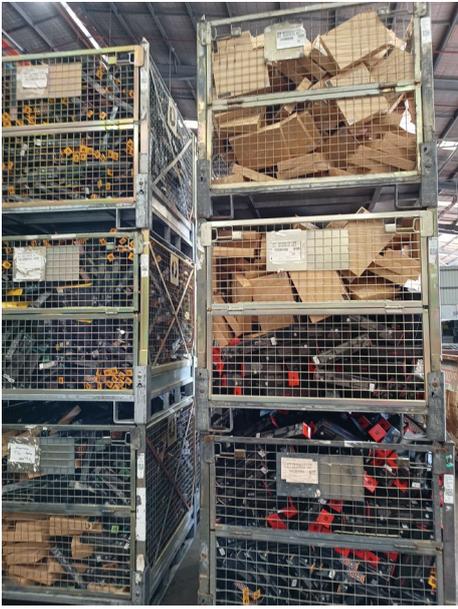
<p>Photo Number: G34, G35, G37, G113 (cont.)</p>	<p>Date: 10/7/2023</p>

<p>Description:</p> <p>Waste types observed onsite.</p> <p>All waste was observed to be stored within buildings.</p> <p>Baled material did not exceed 4m high.</p>

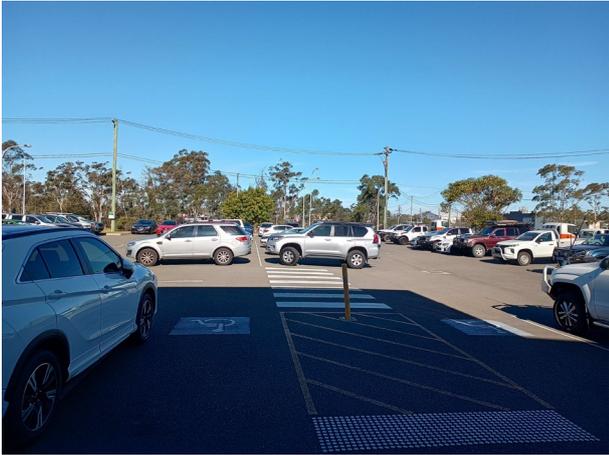
<p>Photo Number: G69, G70</p>	<p>Date: 10/7/2023</p>

<p>Description:  Adequate parking was observed.  No vehicle was observed to be queuing on the public road.</p>

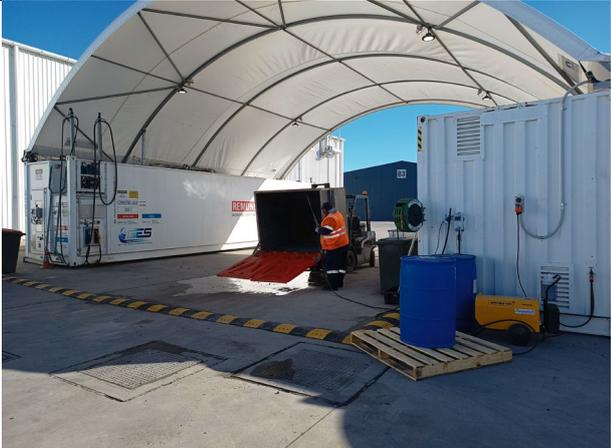
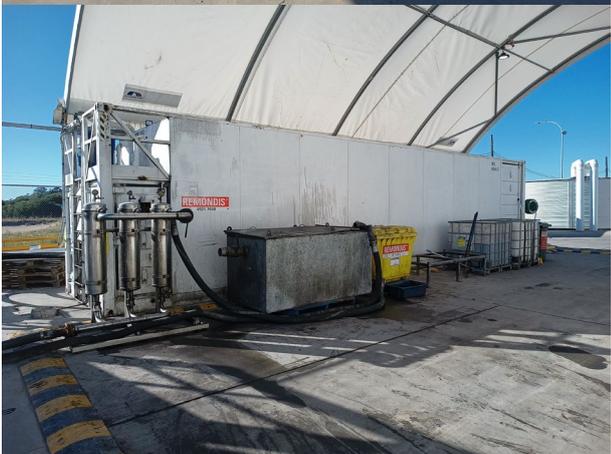
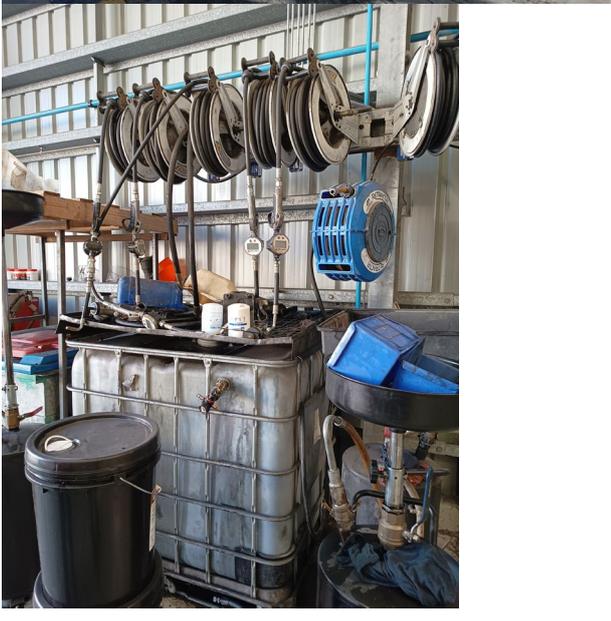
<p>Photo Number: G76</p>	<p>Date: 10/7/2023</p>

<p><b>Description:</b></p> <p>Chemicals were observed to be stored in paved areas.</p> <p>Bunding was observed in the majority of the containers.</p> <p>Spill kits were observed.</p> <p>The workshop was observed to be paved, with no drain observed. Paving was observed to be in good condition.</p>

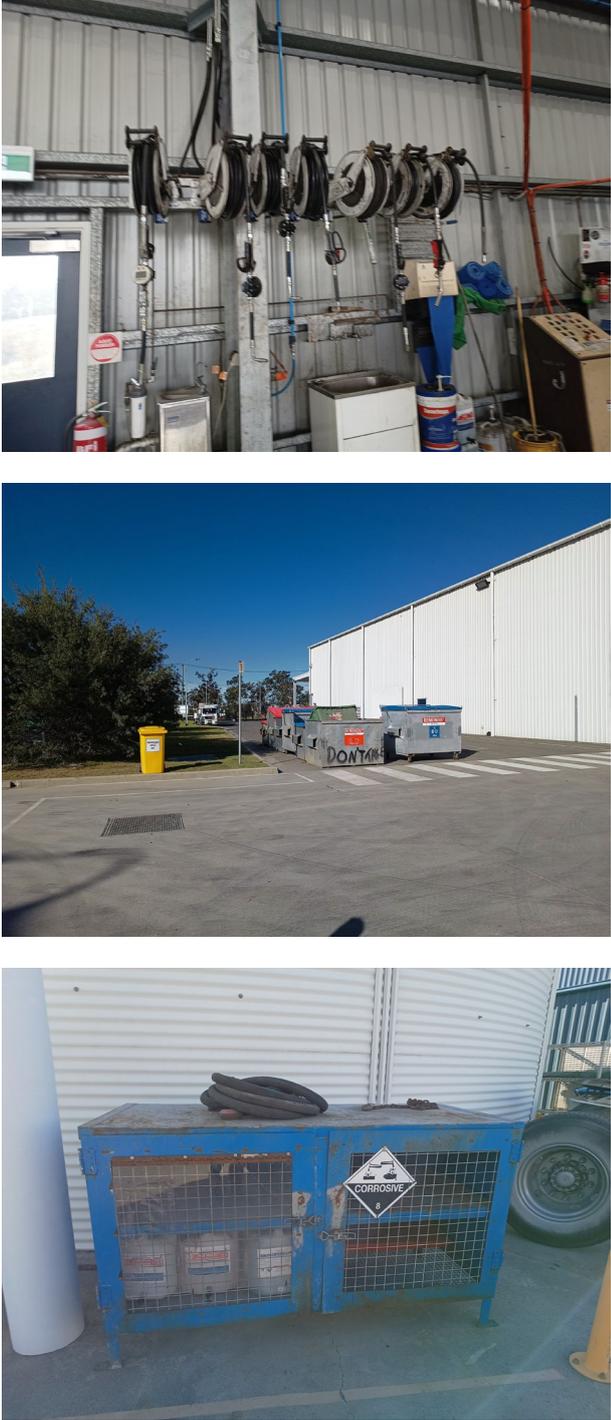
<p>Photo Number: G76</p>	<p>Date: 10/7/2023</p>

<p><b>Description:</b></p> <p>Chemicals were observed to be stored in paved areas.</p> <p>Bunding was observed in the majority of the containers.</p> <p>Spill kits were observed.</p> <p>The workshop was observed to be paved, with no drain observed. Paving was observed to be in good condition.</p>

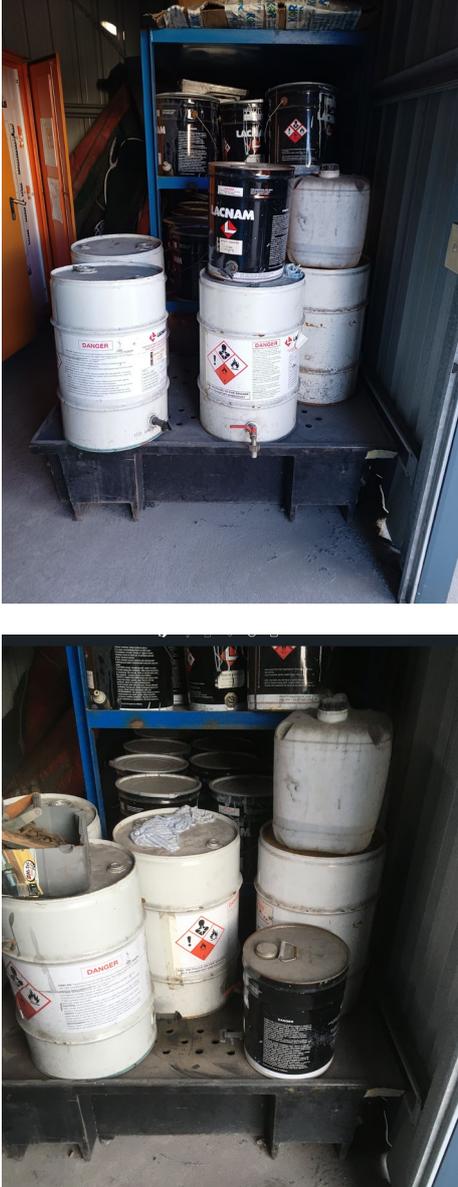
<p>Photo Number: G76</p>	<p>Date: 10/7/2023</p>

<p><b>Description:</b></p> <p>Chemicals were observed to be stored in paved areas.</p> <p>Bunding was observed in the majority of the containers. At the time of site inspection, some of the taps were located outside the bunds. These were rectified after the site inspection (see second photograph).</p> <p>Spill kits were observed.</p> <p>The workshop was observed to be paved, with no drain observed. Paving was observed to be in good condition.</p>

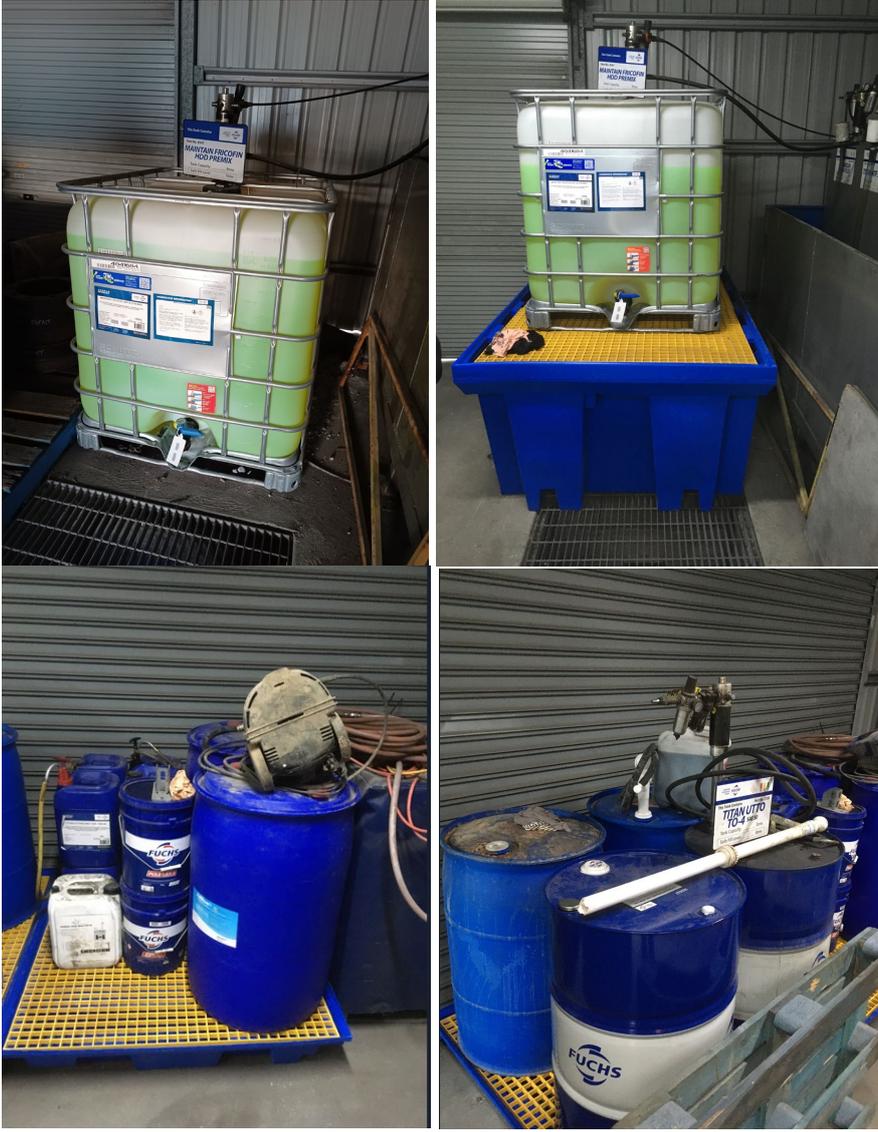
<p>Photo Number: G76</p>	<p>Date: 10/7/2023</p>

<p><b>Description:</b></p> <p>Chemicals were observed to be stored in paved areas.</p> <p>Bunding was observed in the majority of the containers.</p> <p>Spill kits were observed.</p> <p>The workshop was observed to be paved, with no drain observed. Paving was observed to be in good condition.</p>

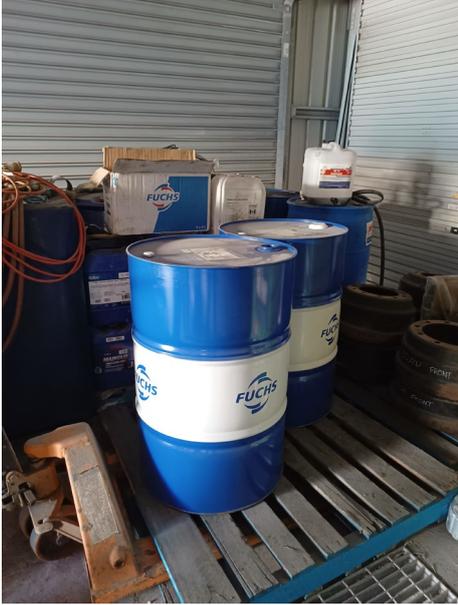
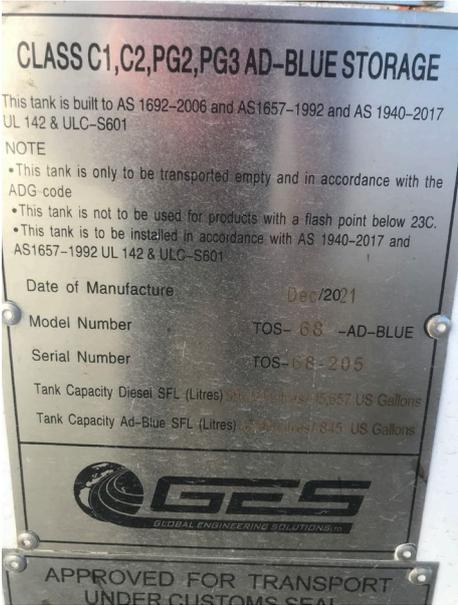
<p>Photo Number: G76</p>	<p>Date: 10/7/2023</p>

<p><b>Description:</b></p> <p>Chemicals were observed to be stored in paved areas.</p> <p>Bunding was observed in the majority of the containers.</p> <p>Spill kits were observed.</p> <p>The workshop was observed to be paved, with no drain observed. Paving was observed to be in good condition.</p> <p>Diesel tank label indicates compliance with AS 1692-2006 and AS1657-1992 and AS1940-2017 UL 142 &amp; ULC-S601.</p>

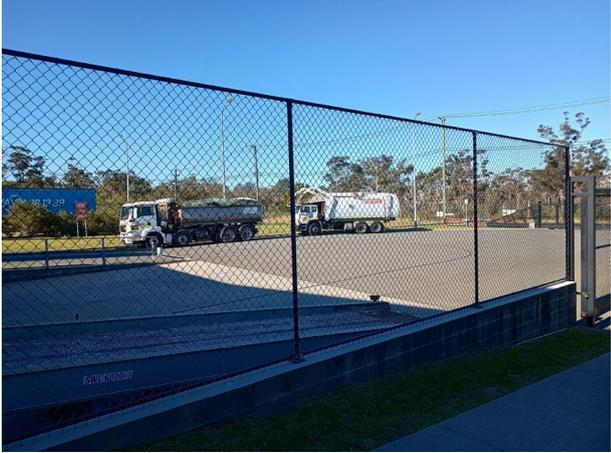
<p>Photo Number: G160</p>	<p>Date: 10/7/2023</p>

<p>Description: Trucks parked near the gate had the loads covered.</p>
